# Building Surveys and Reports

4<sup>th</sup> Edition

**James Douglas BSc, MRICS, MBEng, FHEA  
and Edward A. Noy FASI, ARSH**

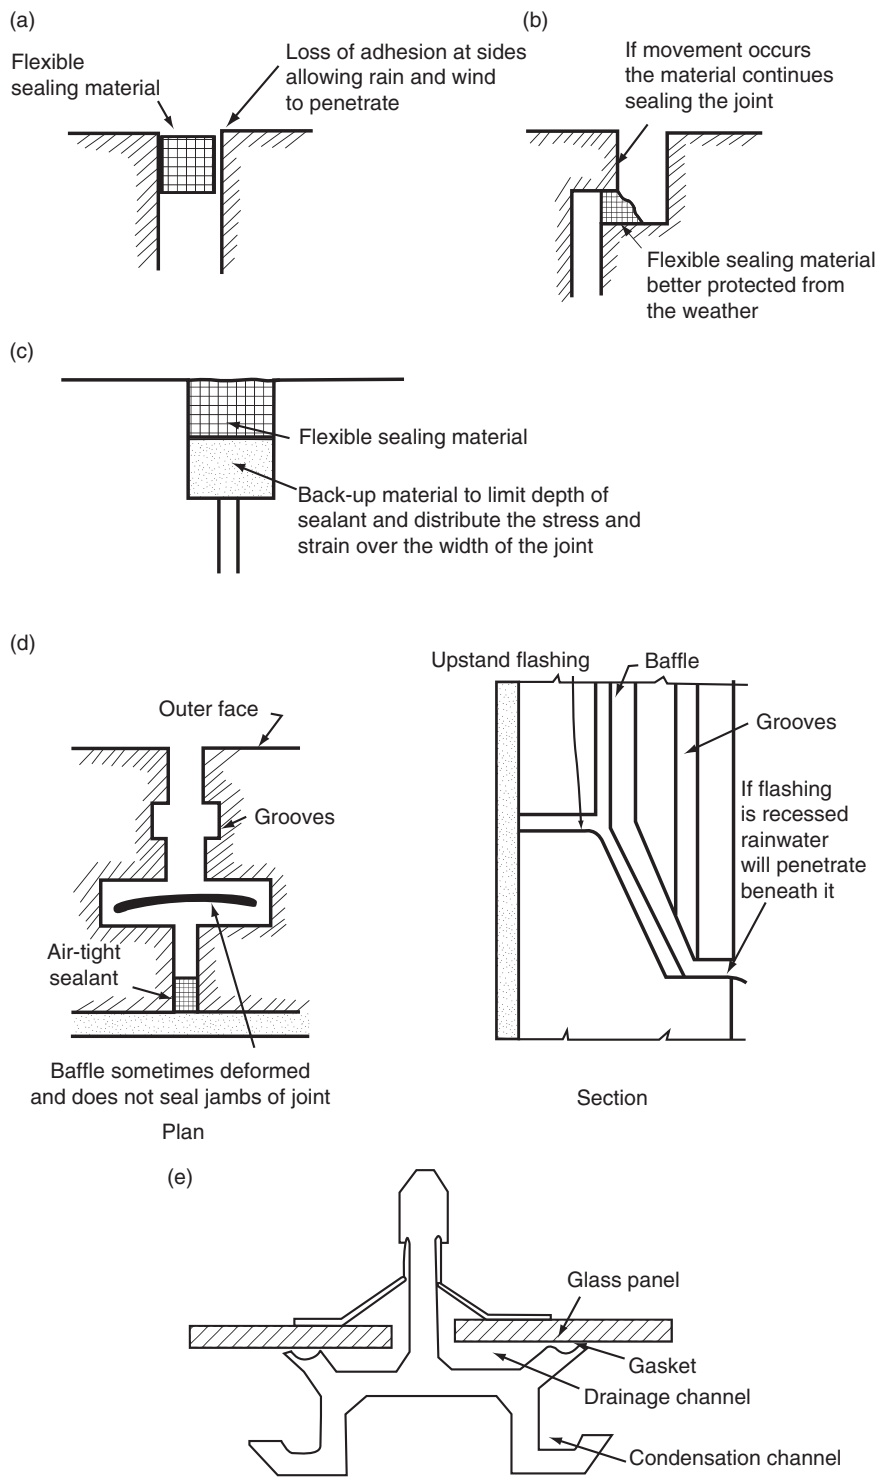
Figure 7.4 Joint problems. (a) Butt joint, (b) lap joint, (c) back-up material, (d) drained joint and (e) vertical gasket joint in patent glazing

Accurate assembly of the cladding units is essential and the movement expected between the sides of the joint must be properly calculated. Unfortunately, there have been many failures of sealants, some of which are caused by butt joints which are too deep and too narrow causing loss of adhesion at the sides of the joint (see Figure 7.4a) or loss of cohesion in the sealant. If the sealant material is unduly

stressed it will tend to break down. The lap joint shown in Figure 7.4b is often preferred because it is better protected from the rain, snow and wind and therefore imposes less strain on the sealant. In order to limit the depth of the sealant and distribute the stress and strain over the width of the joint, a back-up material is often used. The back-up materials usually consist of expanded plastics or fibre building board, but if butyl mastics are used as a sealant then it is usual to use a polyurethane sponge (see Figure 7.4c).

One of the most successful concrete cladding joints is the open drained joint which reduces the risk of rainwater penetration. The vertical joints between the panels shown in Figure 7.4d usually consist of an outer groove to trap rainwater which discharges over an upstand flashing at the base of the panel. The centre portion consists of a baffle which if deformed does not form a satisfactory seal at the jambs of the recessed joint. If rainwater penetrates the grooves in the outer face and the defective baffle there is only the inner barrier consisting of a sealant to prevent damage to the inner face of the cladding. The inner sealant must be air- and weather-tight. Flashings at the lower edges direct any rainwater to the outside face which may have penetrated the baffle. One common failure is that the flashing may be recessed behind the panel face allowing rainwater to penetrate beneath it. Gaskets are preformed materials extruded from plastics or rubber, and widely used for securing glass panels and for waterproofing a joint (see Figure 7.4e). They do not depend on adhesion, but on pressure against the joint surfaces to provide a seal. Gaskets cannot adjust well to rough surfaces, and are, therefore, best used between smooth surfaces. One of the difficulties in forming a gasket joint on site is the mitre at the corners. This is a joint that should be carefully checked during the site investigation. Points of weakness are also likely to be found where there is a change in the construction of the cladding or where window or door openings occur. Sills should be carefully checked to ensure that they throw rainwater clear of the cladding below.

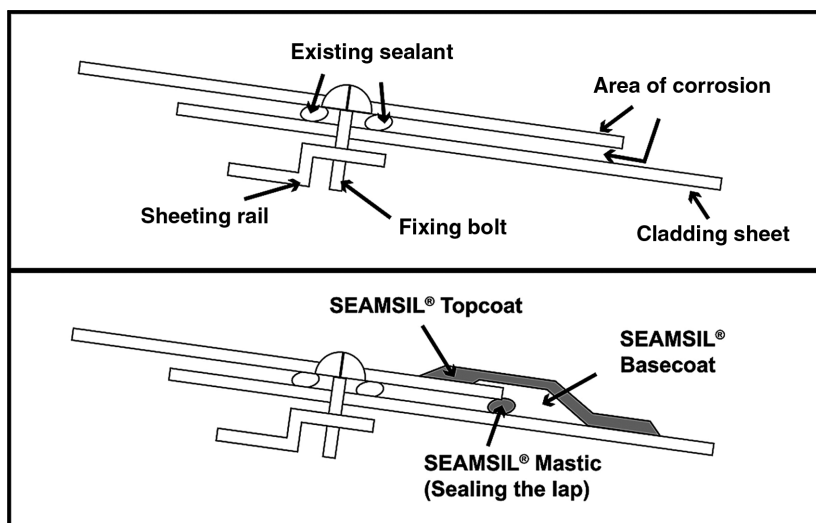
**Figure 7.5** Before and after SEAMSIL® overlap detail (courtesy of Delvemade Ltd)

There are now several proprietary treatments of edge corrosion available (see Figure 7.5). Delvemade Ltd is one such system ([www.delvemade.co.uk](http://www.delvemade.co.uk)), which uses an alkoxy silicone (non-acidic) sealer application. An alkoxy silicone should be odourless and have a low modulus of elasticity. It is an excellent corrosion coating. If the silicone gives off a vinegar odour it contains an acidic rather than an alkoxy base, and therefore should not be used, as it has little resistance to corrosion.

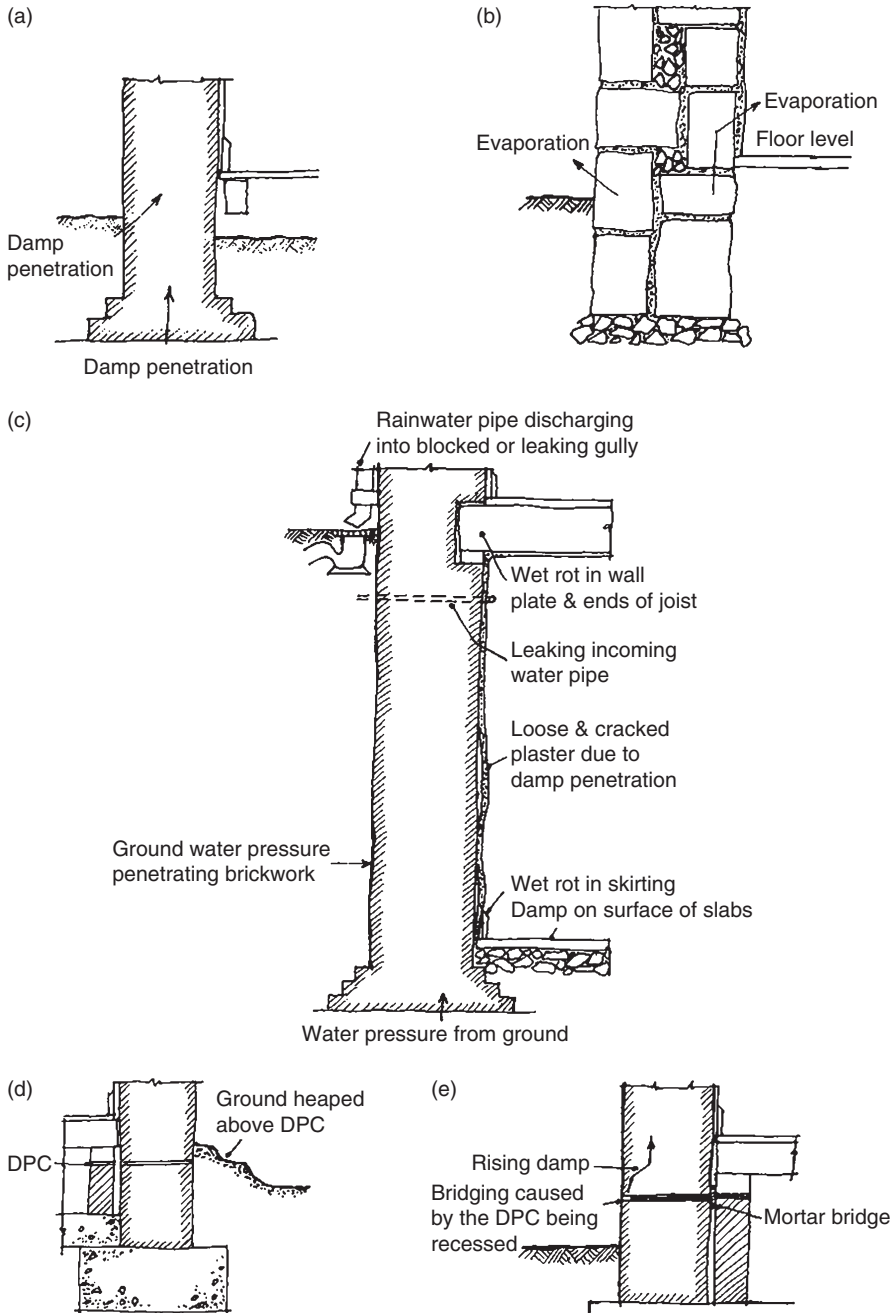
**Figure 8.1** (a) Typical early nineteenth century external wall construction with no DPC. (b) Traditional solid stone wall. No DPC. (c) Typical damp problems in old basement walls. (d) DPC covered by earth. (e) Defects caused by bridging DPC

As mentioned in Section 8.1 the ground around the foundations is often damp; moisture rises into the brick or stonework by capillary attraction and unless a DPC is provided above ground level the moisture can rise, causing considerable dampness to walls and floors. It is, therefore, important that the surveyor makes a careful examination of the base of the wall to ascertain the existence or absence of a DPC. If there is no damp course, dampness will show along the bottom of both external and internal faces causing discoloration, mildew and peeling decorations. The damp will rise in a wall or partition to a height at which there is a balance between the rate of evaporation and the rate which the damp can be drawn up by capillary attraction. The line of dampness due to the absence of DPC is usually continuous and fairly horizontal and in severe cases can reach a height in excess of 1 m (see BRE Digest 245). Figure 8.1a shows a typical early nineteenth century external wall construction with no DPC and no foundation concrete.

The important point for the surveyor to remember is that any treatment which prevents evaporation such as waterproof rendering internally or externally, will only cause the damp to rise higher before it can evaporate, causing more problems (Massari & Massari, 1993)! Any treatment recommended (Burkinshaw, 2009) is a matter requiring careful judgment (see Figure 8.1b).

Flag stones or brick floors were usually laid on the bare earth and moisture rising from the ground is common. The surveyor will often find an impervious finish has been laid over the solid floor which has become very wet underneath, and probably affected by rot. Figure 8.1c shows typical problems in an old basement wall.

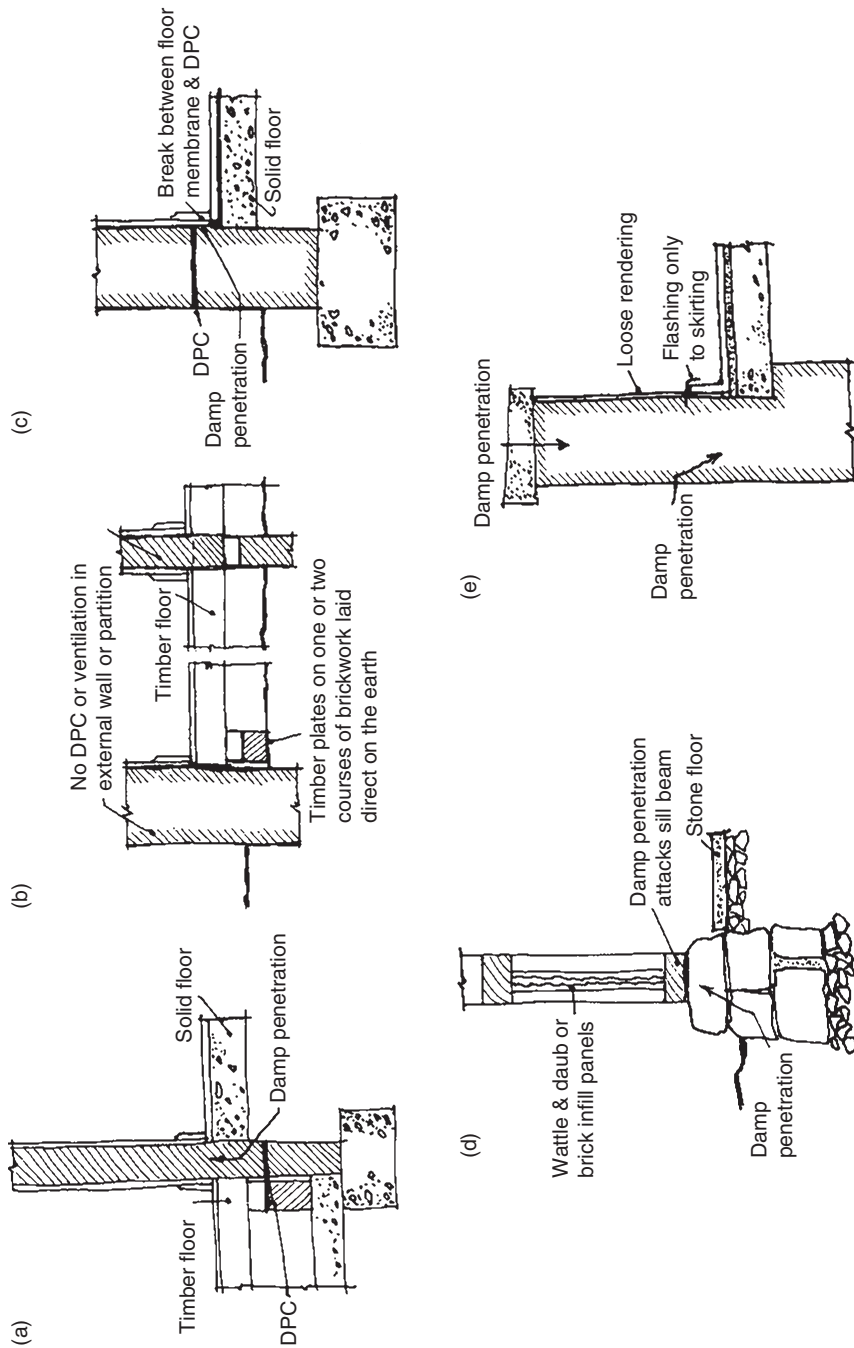
Figure 8.2 (a) Incorrect DPC insertion in partition wall. (b) Typical early nineteenth century timber floor construction. (c) Inadequate jointing between floor membrane and DPC. (d) Typical base detail of timber framed building. (e) Defects caused by the absence of DPCs in parapet wall

Another common defect found in domestic property is a partition wall with a solid floor on one side and a joist floor on the other. If the DPC is a few millimetres below the concrete floor then damp can rise through the unprotected gap (see Figure 8.2a).

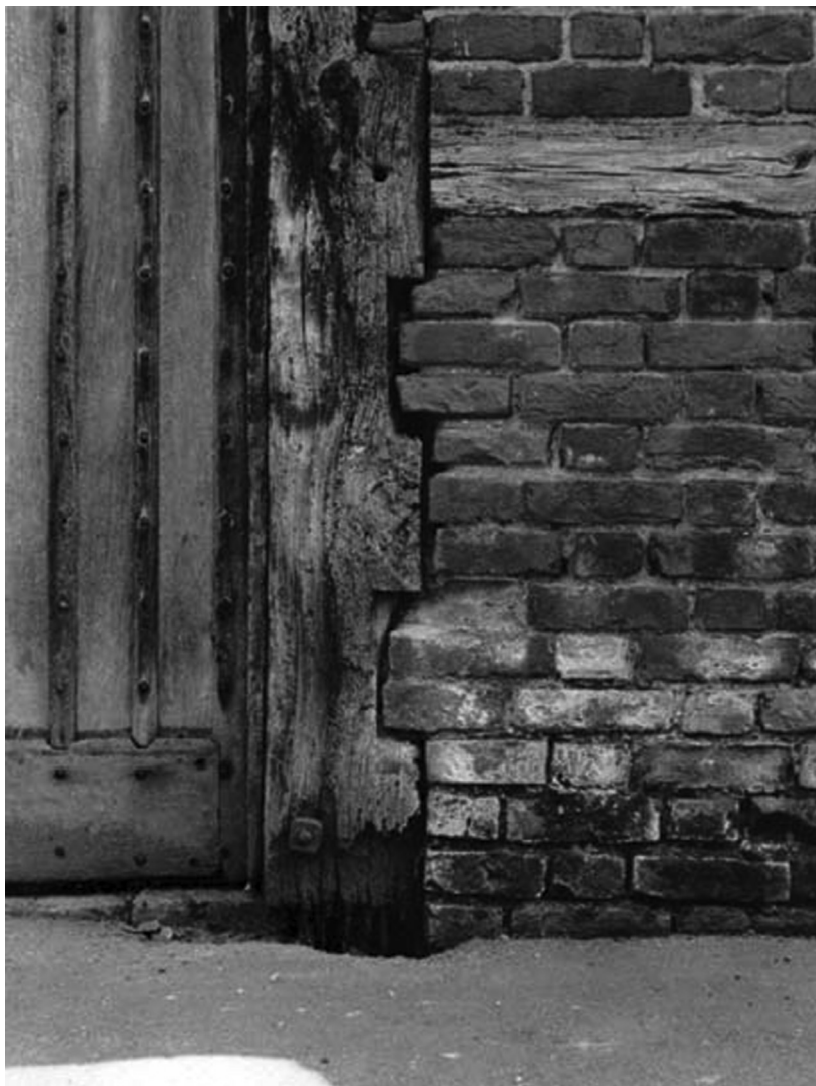
**Figure 8.3** Effects of rising damp and woodworm in a timber-framed building

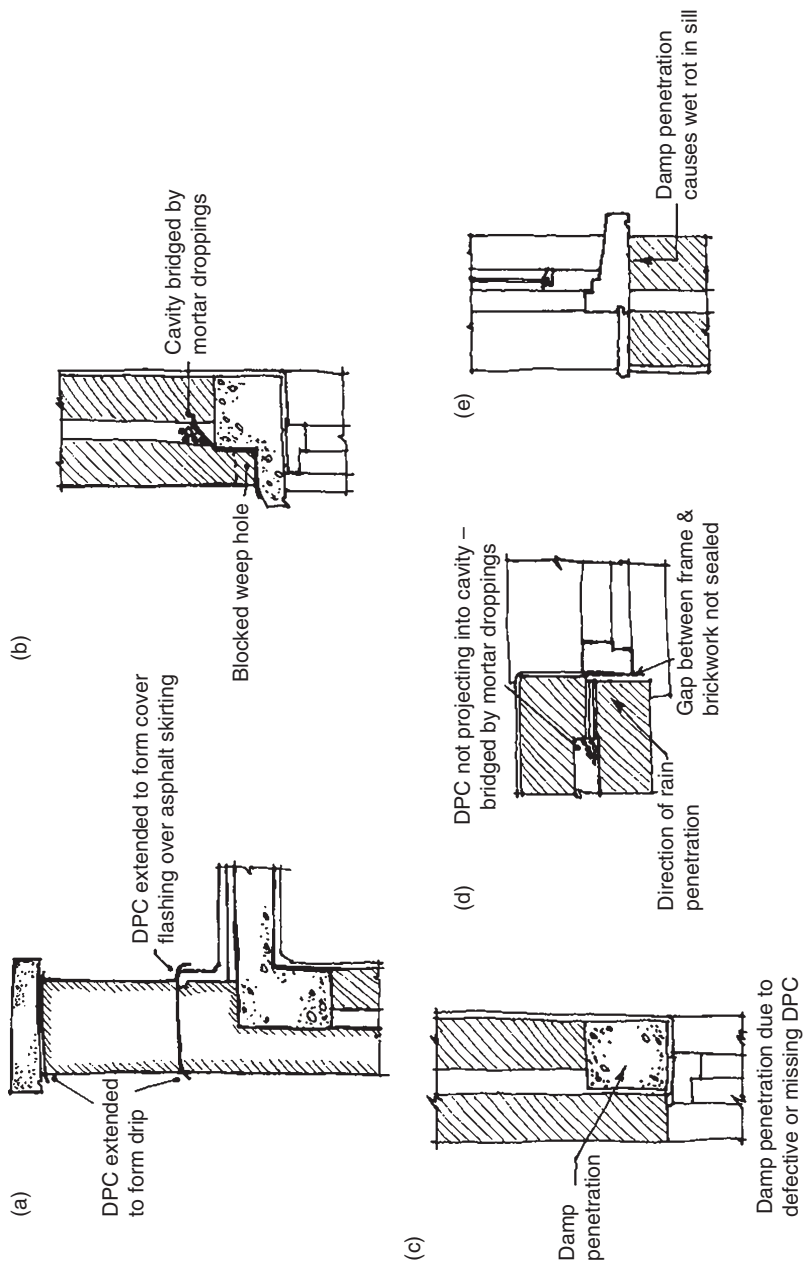
Figure 8.4 (a) Correct detail for DPCs in solid parapet wall. (b) Bridging of DPC over opening. (c) Damp penetration due to defective or missing DPC. (d) Damp penetration due to poor detailing of DPCs and jointing to reveal opening. (e) Damp penetration due to omission of DPC under sill

is also a common fault with DPCs over window and door openings as shown in Figures 8.4b and c where bridging of the cavity is caused by excessive mortar droppings building up off the DPC or due to a faulty or missing damp-proof tray. Damp patches on the plaster about 300 mm above the head of the window usually indicate mortar droppings collecting at the head of the damp-proof tray. The weep holes externally should also be examined to ensure that they are not blocked.

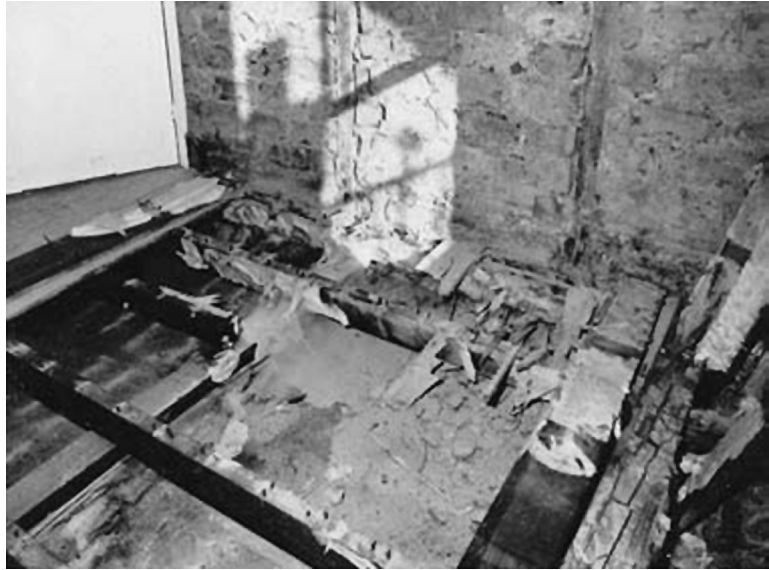
**Figure 9.1** Dry rot spore dust in floor joists and partition. Reproduced by permission of Harsco Infrastructure

In the first case described above the ground floor construction is the most likely place for dry rot to appear. The construction consists of timber joists supported on sleeper walls built of the site concrete. If the sleeper walls are well provided with honeycomb openings, and the external walls have enough air vents, the circulation of air may be sufficient to carry away the moisture and so prevent the fungus starting. However, it often happens in course of time the air vents become clogged or covered with earth (see Chapter 8). Pockets of stagnant air and rising damp through poor quality site concrete or brickwork are the primary contributory causes of fungal decay. The timber will absorb the moisture and so produce the fungi which decompose the wood. Figure 9.1 shows ground floor joists badly affected by dry rot attack.

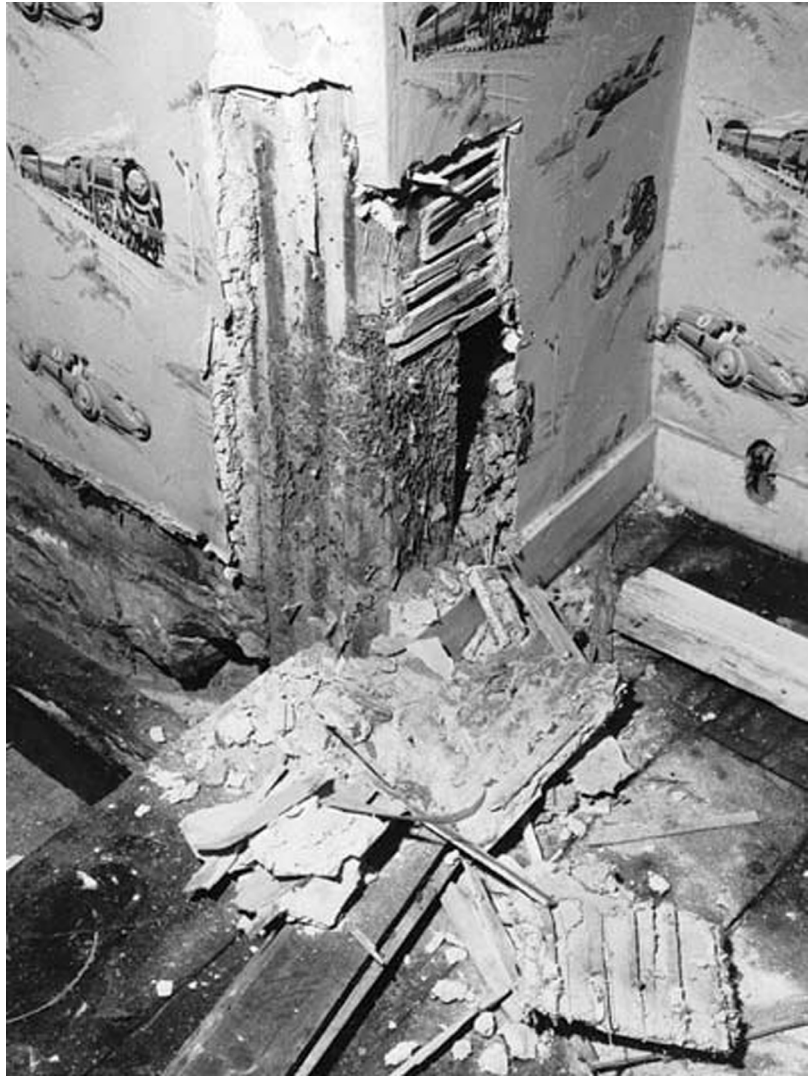
**Figure 9.2** Effects of death watch beetle. Reproduced by permission of Harsco Infrastructure

old hardwoods, usually oak and chestnut, and most damage occurs in built-in parts of a structure such as end beams, wall plates and poorly ventilated places (Figure 9.2).

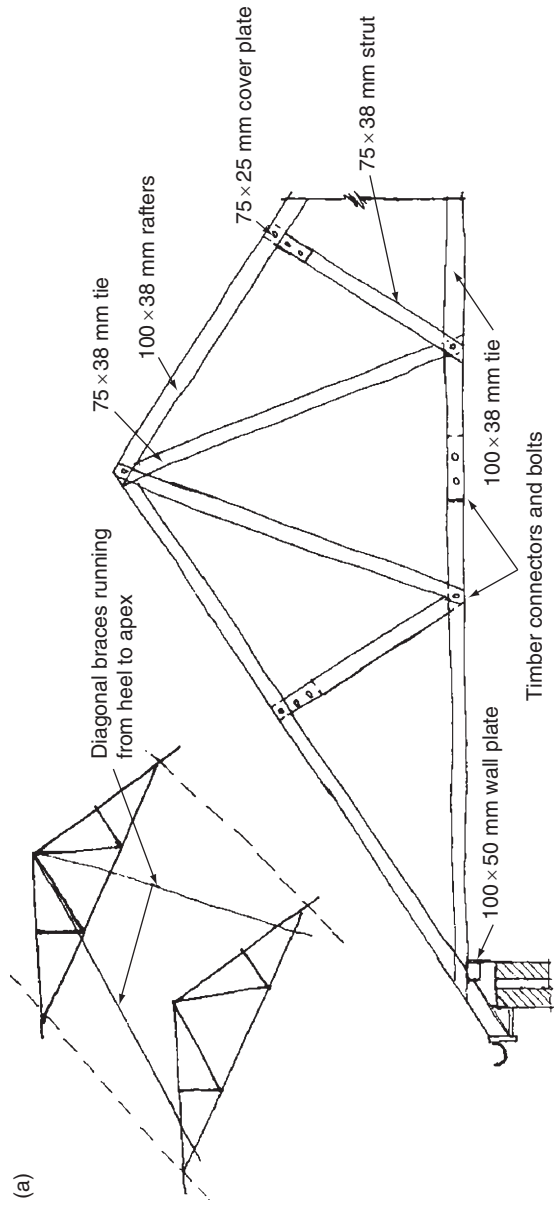
Figure 10.2 (a) Trussed rafters

During the past 30 years many experiments have been made in the construction of both flat and pitched roofs with the object of effecting economies in the use of material. A very economical system is the trussed rafter which is now used in over 90% of new domestic work. It consists of lightweight truss units formed into a number of strongly built triangles that span wide areas, generally spaced at about 600 mm centre to centre. The trusses are available for pitches of 40° for plain tiles and 35° for interlocking tiles or slates. No purlins or common rafters are used. The advantages are that there is no need for a loadbearing partition on the first floor and the trusses are suitable for prefabrication. The trusses are made from timbers of uniform thickness secured at the main joints with double-sided timber connectors and bolts (see Figure 10.2a).

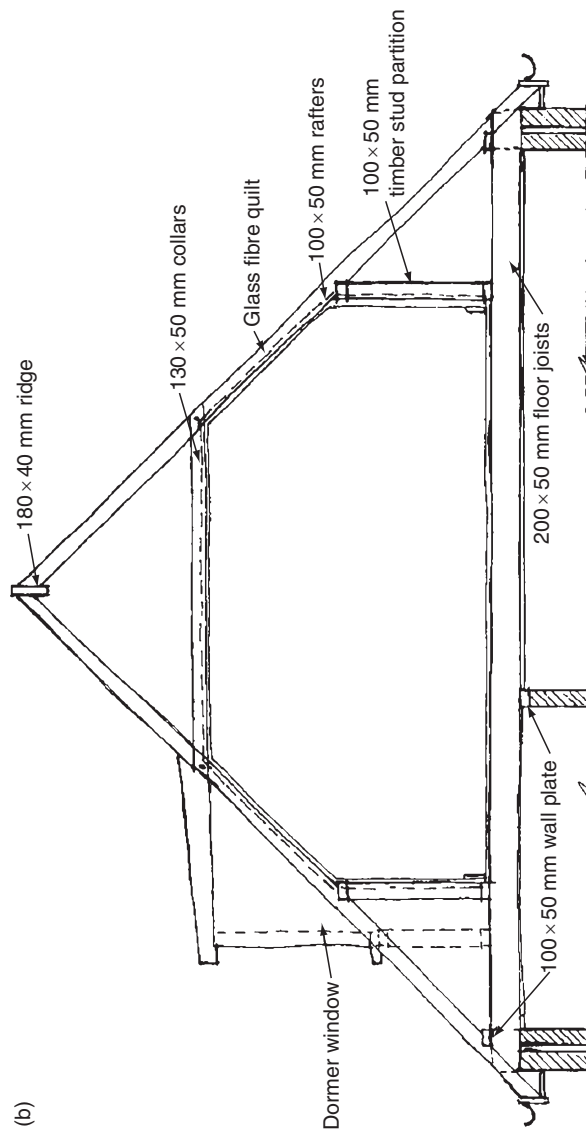
Figure 10.2 (b) Room in roof space

are also the ceiling joists and timber studs clad in plasterboard with skim coat plaster finish form the walls. Dormer windows and sloping ceilings make attractive but sometimes cold rooms, but in the more modern dwellings glass fibre quilt is often used to insulate the triangular space and ceiling (see Figure 10.2b). The mansard roof is of similar construction, but without the sloping ceilings.

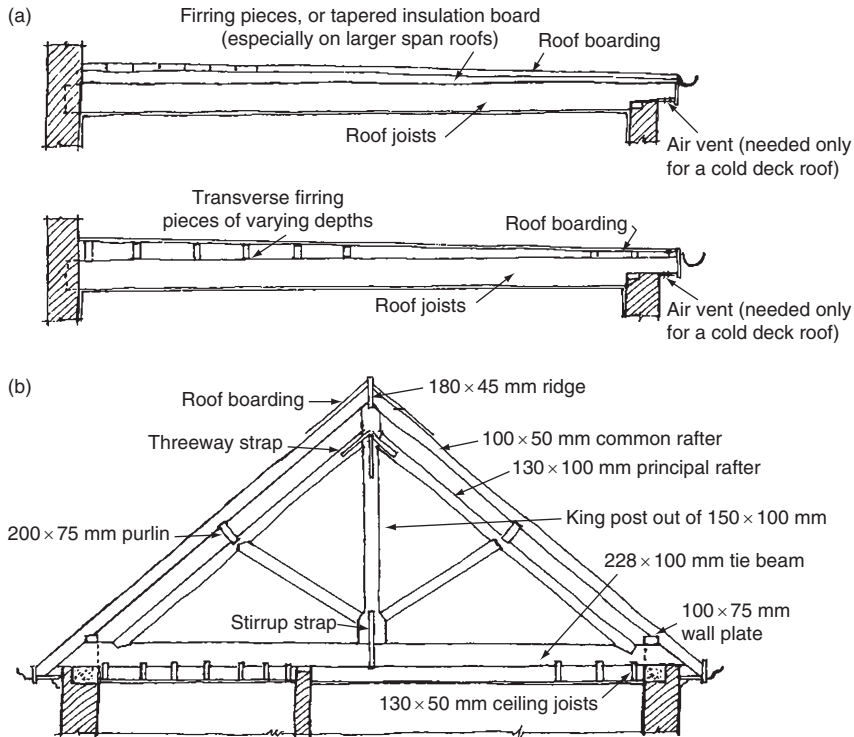
**Figure 10.3 (a) Flat roof construction. (b) King post roof**

During the eighteenth and nineteenth centuries larger span roof trusses followed the pattern shown in Figure 10.3b for the majority of the larger domestic dwellings, light industrial and commercial buildings. This type of roof has been included because surveyors are often called upon to examine an old building where this type of construction is met with. The example shown is a king post

truss, but there were many variations and this type together with the queen post reached their ultimate design during the mid-nineteenth century. The truss supports the purlins which in turn support the common rafters. The roofs were usually close boarded and covered with slates making a sound insulated loft. In all cases the joints were strengthened with iron straps and bolts.

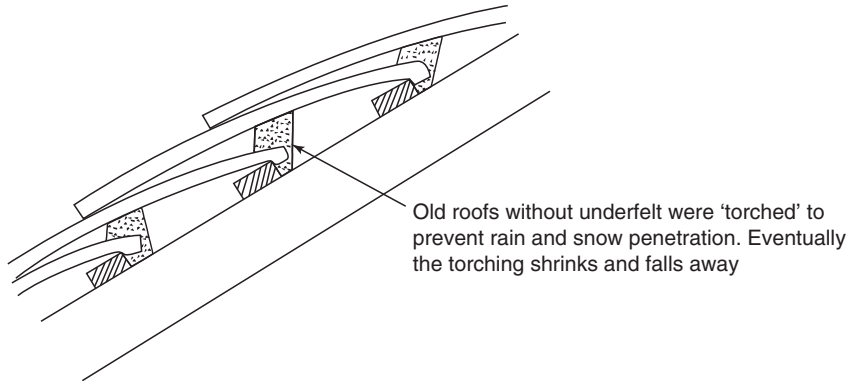
**Figure 10.6** Method of 'torching' to underside of roof tiling

- A great number of domestic buildings built before 1940 have roofs without either underfelt or boarding. To prevent rain or snow penetration 'torching' has been used on the underside of the tiles and consists of a mixture of lime mortar and cow hair. The mixture was spread behind each batten to fill the space between the tiles. The disadvantage with 'torching' is that it tends to shrink and fall away. The torching should be carefully examined and commented on (Figure 10.6).

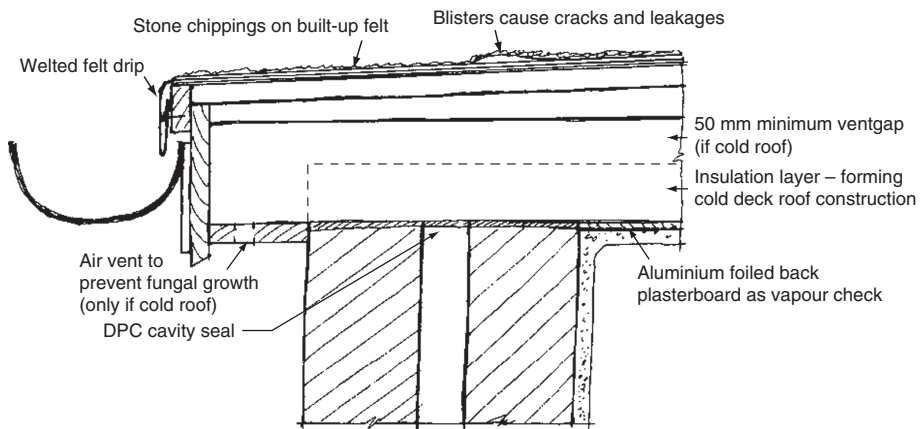
Figure 10.7 Built-up roofing – eaves detail

- (2) As mentioned in Chapter 8, condensation can present serious problems in roofs of this type. Moisture can be prevented from entering the roof by the provision of a vapour barrier such as plaster board and ventilation in the roof void to prevent fungal growth. The entrapped air or moisture between the layers of felt or between the felt and the substructure will cause the felt to lift in the form of 'blisters'. The blisters are not necessarily a sign of failure, but should be carefully examined to see whether any foot pressure has been applied to cause the blister to crack and form a passage for water penetration. One of the most common defects is to find that no provision has been made for ventilation and a vapour barrier. It is, therefore, important that the surveyor endeavours to ascertain the nature of the original construction (see Figure 10.7).

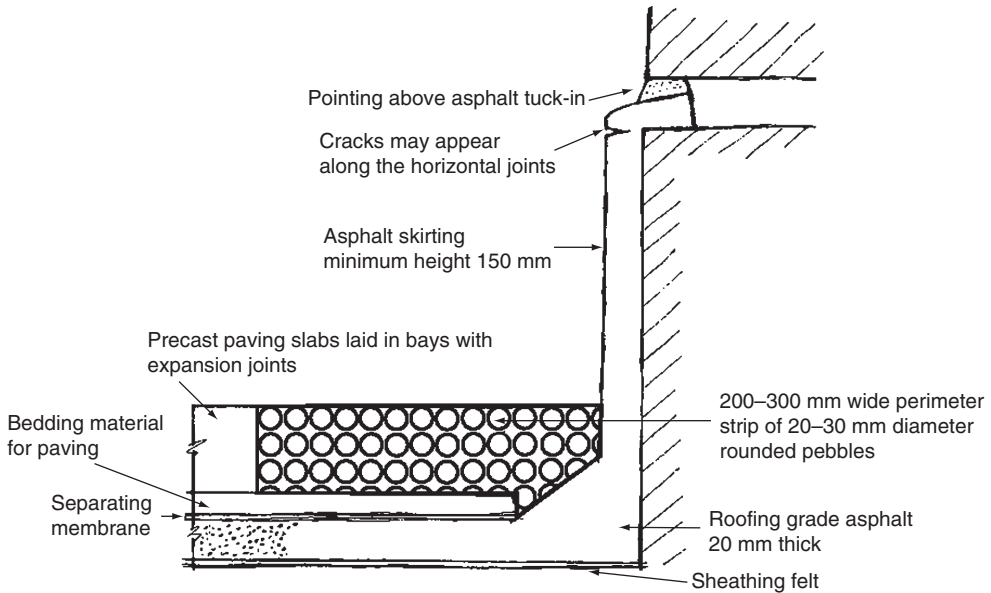
**Figure 10.8 Mastic asphalt to roof garden or car park roof**

Mastic asphalt has one great advantage over metal roof coverings in that it provides a jointless covering, thus avoiding the weaknesses inherent in seams, rolls, drips and welts. It also gives an unobstructive smooth finish which is eminently suitable for flat roofs especially where frequent traffic is anticipated. Mastic asphalt should be laid in two coats each 10 mm thick and to keep the roof free from standing water it

should have a minimum fall of 1:40. An isolating membrane should be provided beneath the asphalt to allow for differential movement (BRE Digest 144).

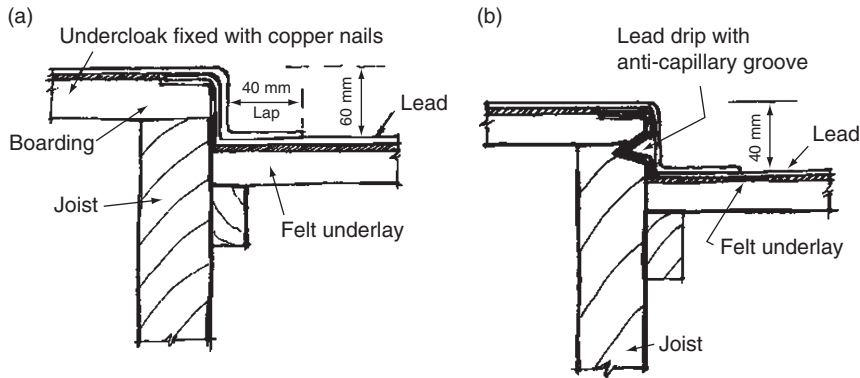
**Figure 10.9 (a) Lead drip. (b) Lead drip with anti-capillary groove**

- (3) One of the most common faults is due to inadequate drips. They are normally 60 mm deep as shown in Figure 10.9a but a minimum depth of 40 mm is permissible if an anti-capillary groove is provided in the vertical face of the drip. This groove prevents rainwater rising and penetrating through to the timber as shown in Figure 10.9b.

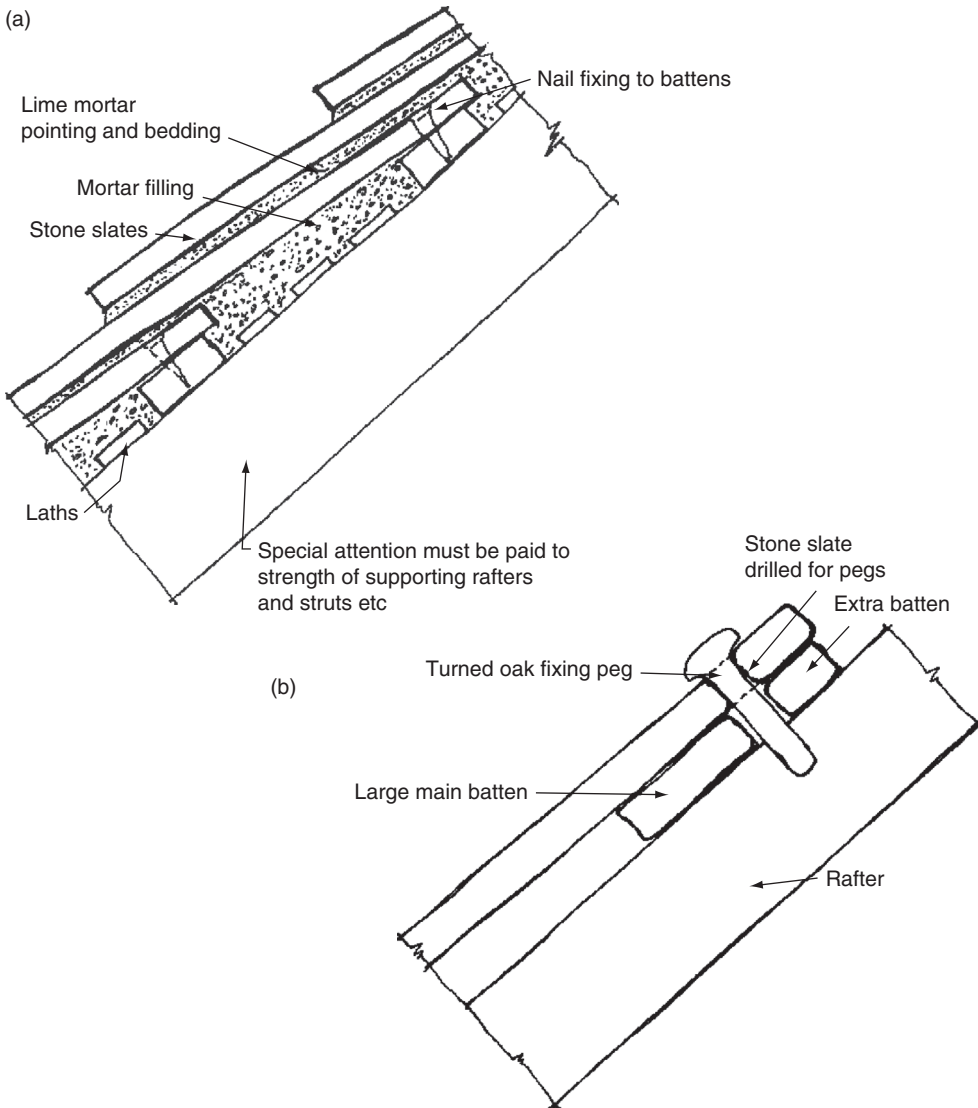
**Figure 10.10 (a) Stone slates sealed by bedding. (b) Tarred oak peg fixing**

Thicknesses vary between 16 or 19 and 25 mm and the colours are natural and differ in accordance with the locality of their quarry. Laying is usually carried out in random widths or random sizes laid in diminishing courses. The common method of fixing is by turned oak pegs in a drilled hole secured between two battens as shown in Figure 10.10b. The extra batten is used to prevent the peg from twisting out of position due to the weight of the slate. Alternatively, battens are laid on open rafters, plasterer's laths being laid between them parallel to the battens and rendered with lime mortar solid to the top face of the batten. The stone slates are then bedded, pointed and head nailed to the battens as shown in Figure 10.10a. Ridges and hips are usually finished with sawn stone angular cappings or half-round clay tiles bedded in mortar. Valleys are generally swept as open gutters. Close mitring is not particularly easy with this type of roof. Figure 10.11 shows a timber roof structure after stone slates have been removed.

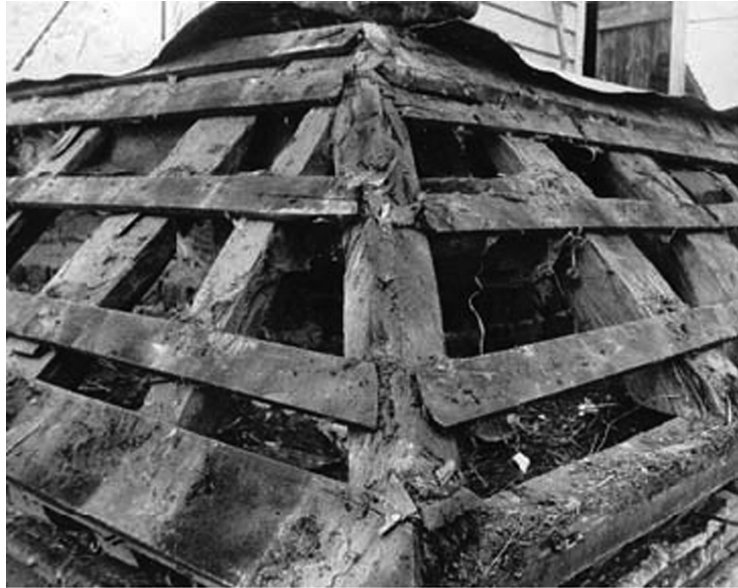
**Figure 10.11 Timber roof structure after worn stone slates have been removed**

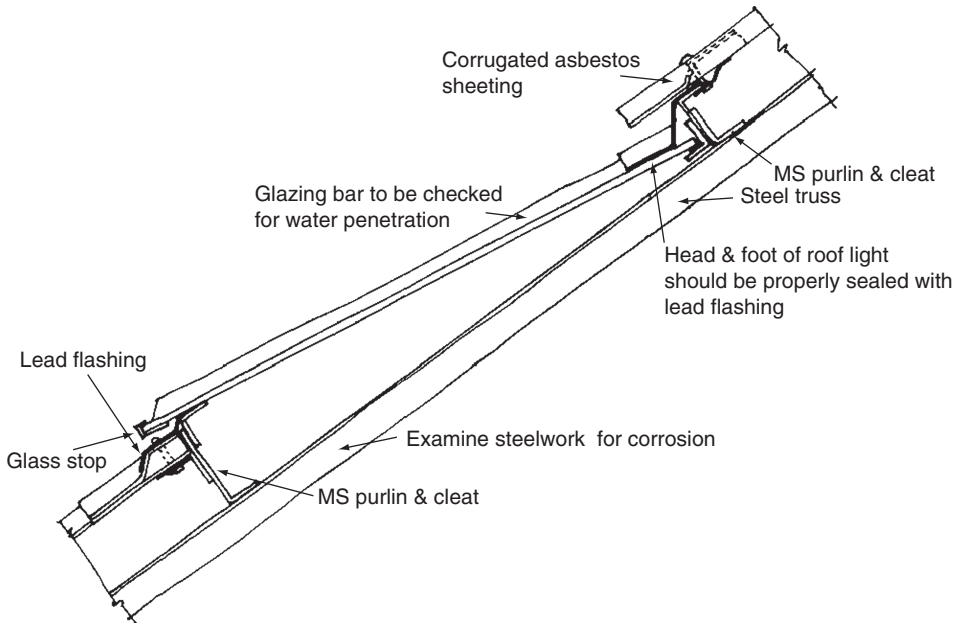
**Figure 10.12 Fixed roof glazing**

- Fixed roof glazing to pitched roofs is used in conjunction with asbestos sheeting or other types of covering and usually consists of patent glazing bars designed to accommodate single or double glazing secured to the roof purlins (Figure 10.12).

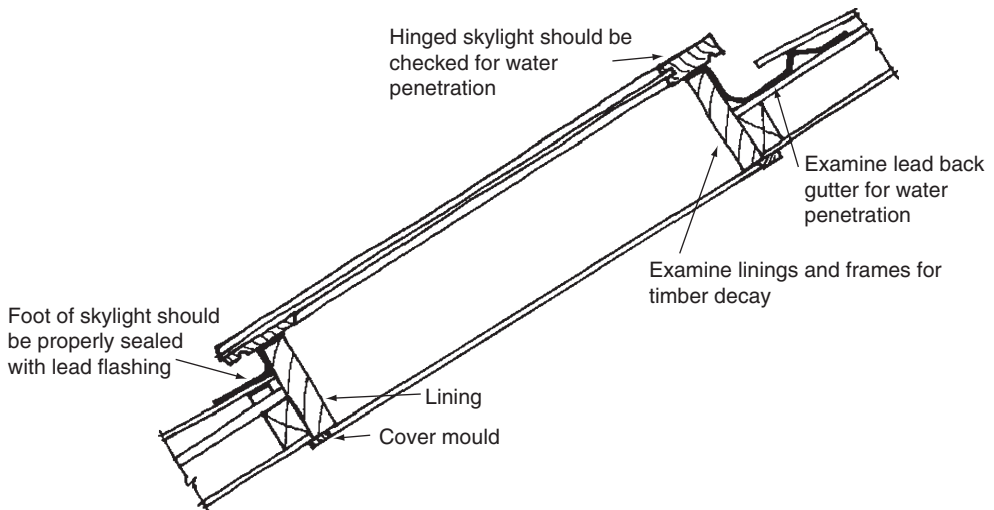
**Figure 10.13 Skylight detail**

- Skylights may be provided in pitched roofs to light a staircase, landing or attic. The skylight may be hinged or fixed (Figure 10.13).
- The traditional form of timber lantern light is still efficient and is found on the flat roofs of many old buildings (Figure 10.14). During the last 40 years they have largely been superseded by dome lights which are manufactured by

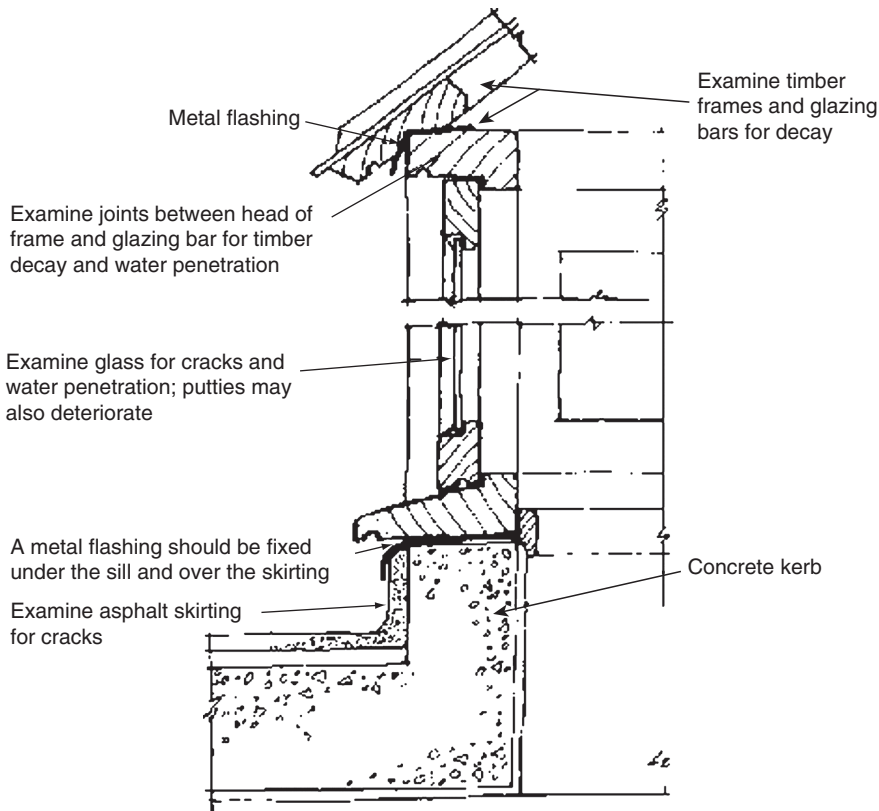
**Figure 10.14** Lantern light

- Skylights may be hinged or fixed, but if the light is hinged penetration of rain-water is likely.
- All forms of upstands to the lantern lights must be in sound condition and should have an angle fillet between roof and upstand. A metal flashing should be fixed under the sill and over the upstand covering as shown in Figure 10.14. Poor detailing in this area is a common cause of water penetration.

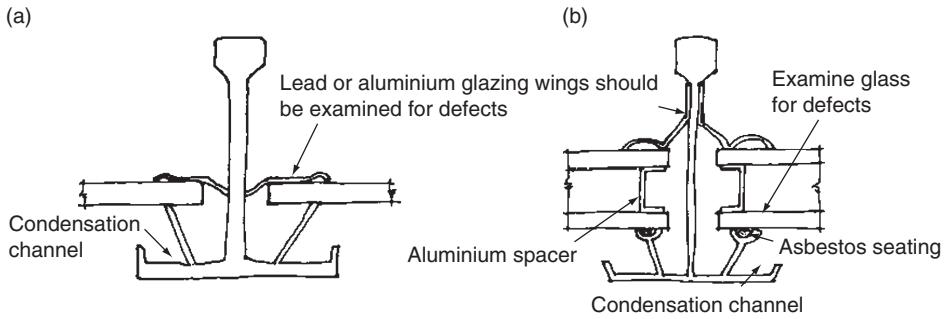
**Figure 10.15 (a) Aluminium glazing bar. (b) Aluminium double glazing bar**

For reasons of safety the glazing to roof lights is usually 6 mm wired glass or cast plate glass. The sheets are from 1–3 m in length and 610 mm in width. Where thermal insulation is important double glazing is used with an air space of 12–18 mm. In small skylights or lantern lights the glazing bars can be made of softwood or hardwood. They are liable to decay and regular maintenance is necessary especially in very exposed positions. There are several proprietary glazing bars in the form of metal T-sections consisting of steel or aluminium alloy sheathed in lead or PVC. The bars incorporate condensation channels and the glass is secured with aluminium spring cover strips or lead wings. The bars are normally trouble free and produce a durable watertight roof light. Figures 10.15a and b show examples of single and double glazing bars. The various items affecting the durability of the roof lights and requiring examination may now be considered:

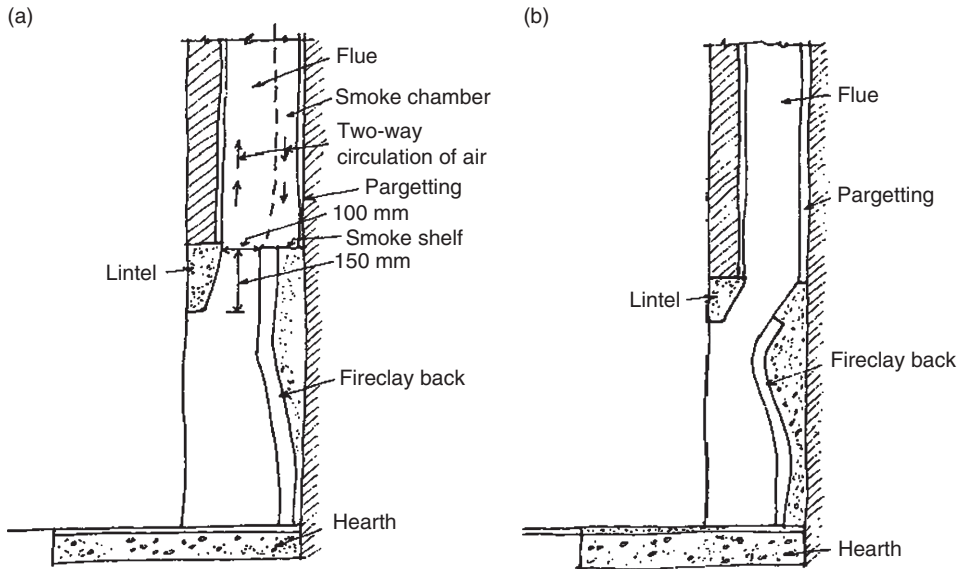
**Figure 11.1 (a) Section through fireplace designed on the principles of Count Rumford. (b) Fireplace design commonly adopted in modern work**

In practice of course, the surveyor will often find that these ideal conditions may not always occur. The fireplace and flue entry shown in Figure 11.1a has been designed on the Rumford principles (Billington & Roberts, 1982) and Figure 11.1b shows a section commonly adopted in modern work which is usually successful. The surveyor will often find that dwellings erected in the past 40 years have been fitted with precast throat units which ensure that the throat is formed to the correct dimensions.

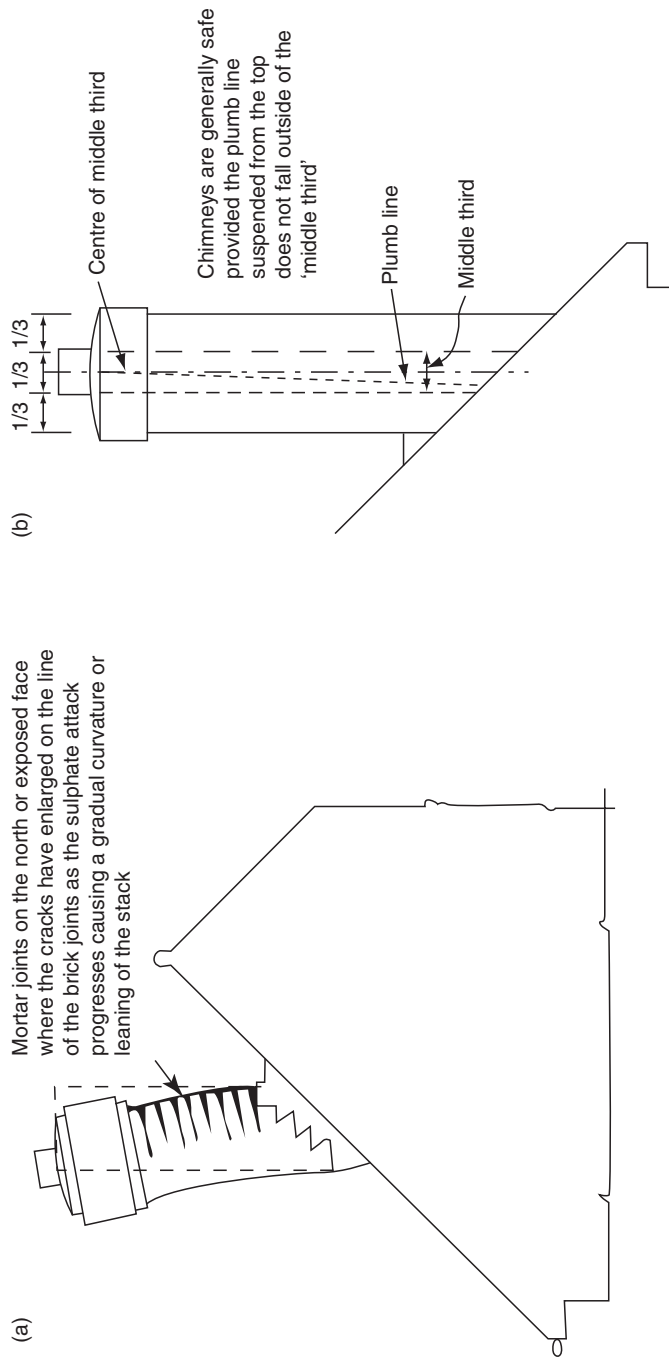
Figure 11.4 (a) Sulphate attack on a typical kitchen boiler flue. (b) Middle third rule

- (1) As already mentioned, sulphate attack causes the mortar to expand and this leads to a gradual curvature or leaning of the stack which can be extensive on rendered stacks. The lining or pargetting can also be attacked by the products of combustion as they rise up the flue. Sulphate attack on a typical kitchen boiler flue is shown in Figure 11.4a where the shrinkage cracks have enlarged on the horizontal brick joints as the sulphate attack progresses. A chimney stack which has begun to lean is generally safe provided a plumb line suspended from the top of the stack does not pass outside the 'middle third' of its area as shown in Figure 11.4b. If the rate of lean appears excessive the surveyor should recommend that the stack should be demolished to the level at which it appears reasonably perpendicular and rebuilt using a sulphate-resisting cement. If the chimney is old and is to be used in conjunction with a gas appliance and is not protected with a flue liner, the rebuilding of the stack will provide a good opportunity to install a flexible liner.

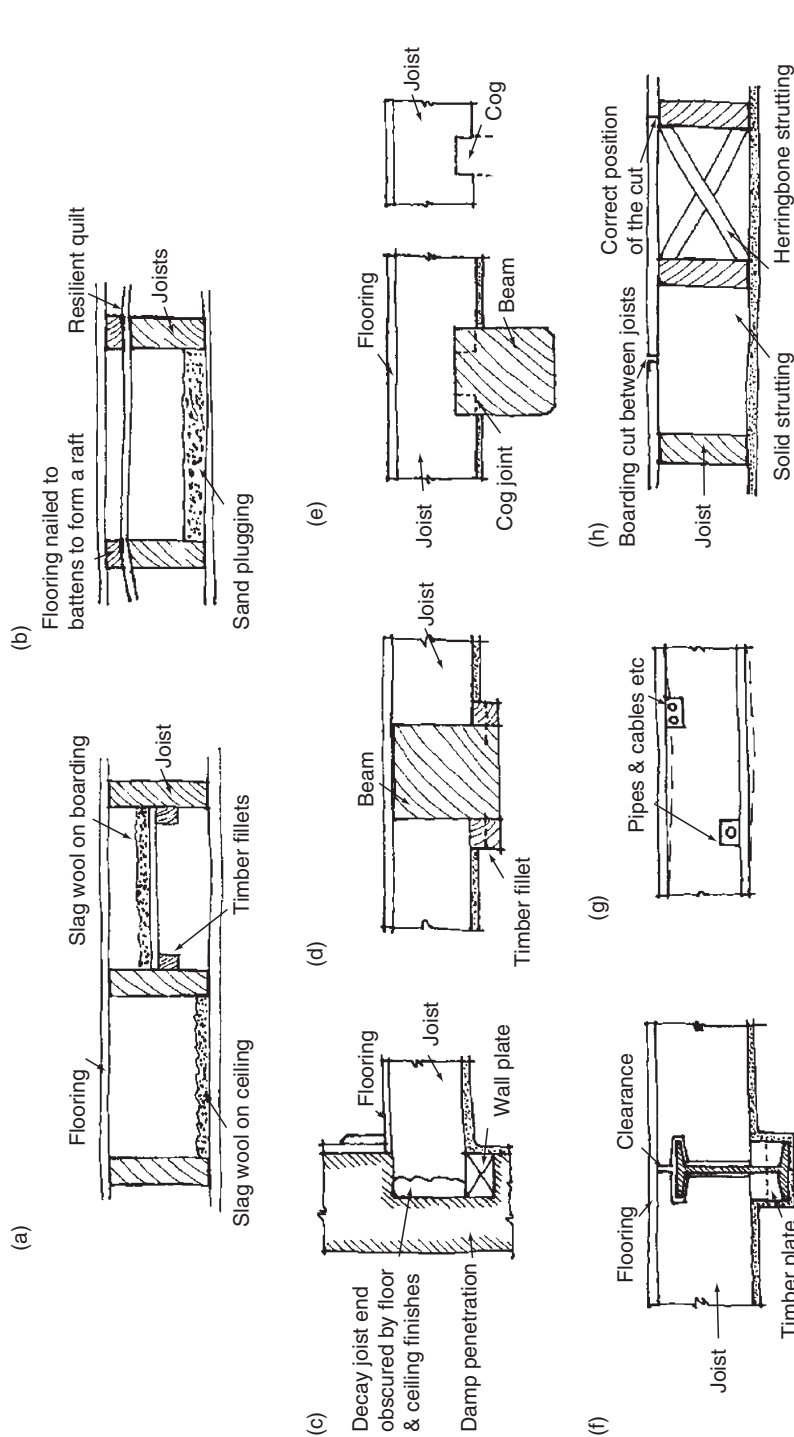
Figure 12.1 (a) Two methods of sound insulation between floors. (b) 'Floating floor' for sound insulation. (c) Joists built into solid wall without an air space. (d) Joist resting on fillets nailed to bottom edge of beam. (e) Method of cogging joists over timber beam. (f) Typical notching when RSJs are used. (g) Deflection due to excessive notching. (h) Floorboard jointing and strutting details

After removing some sections of the floor boarding it is fairly easy to recognise the various types of insulation to enable a report to be prepared. A simple method is a layer of slag wool about 75 mm thick resting on the ceiling below as shown on the left-hand side of Figure 12.1a. A better method which is often found in business premises is shown on the right-hand side of Figure 12.1a and consists of an air space above and below the wool. The wool is supported on boarding which is in turn secured to the joists by timber fillets. A third method is shown in Figure 12.1b and consists of a heavy plugging of sand on the ceiling with a resilient quilt draped over the joists known as a 'floating floor'. The principle underlying the design of a floating floor is its isolation from any other part of the structure. It is, therefore, important to ensure that the flooring is nailed to the battens to form a raft and not nailed through to the joists. The floor must also be isolated from the surrounding walls. These are points which require checking during the examination.

The surveyor will sometimes find that the ends of the boards meet between joists forming a cantilever as shown on the left-hand side of Figure 12.1h and will spring under weight. The cut should be made at the middle of the joists as shown on the right-hand side of Figure 12.1h.
